# Mercury Alert

## Antique Mirrors

Elemental Services & Consulting, Inc. (ESCO) was retained to obtain mercury vapor concentrations from an antique dresser with attached mirror. The owner of the dresser upon learning that mercury was used in making mirrors decades ago was concerned that mercury vapor was contaminating their home.

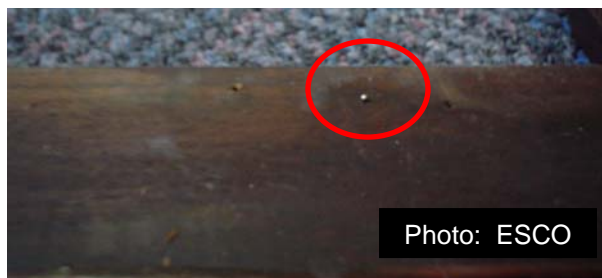
The owners attempted to remove the mirror from the frame in order to replace it and discovered a bead of mercury during the removal process (see photo).

Mercury vapor concentrations following the recovery of the mercury were 0.9  $\mu\text{g}/\text{m}^3$  in the breathing zone, but rapidly dissipated with ventilation to outdoors. The carpeted floor indicated mercury vapor concentrations of 0.5  $\mu\text{g}/\text{m}^3$  – 0.8  $\mu\text{g}/\text{m}^3$  for nearly 2 hours until ventilation to outdoors was complete. Mercury vapor concentrations the following day indicated 0.0  $\mu\text{g}/\text{m}^3$  in the breathing zone and at floor level.

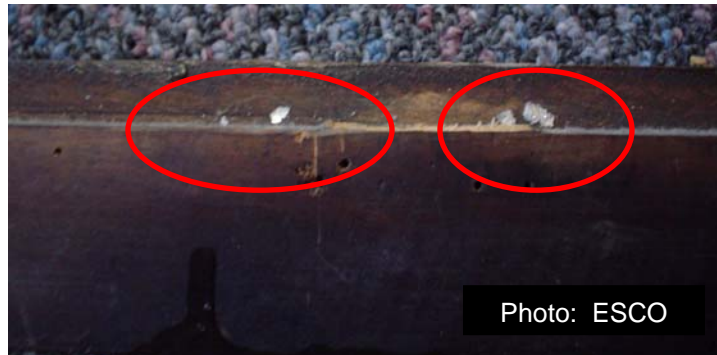
Additionally, flakes of the silver backing were observed around the bevel of the wood holding the mirror in place. Several flakes of silver backing were discovered behind the dresser in the bedroom (see following photograph).

The mercury vapor concentration in the area of these flakes was  $> 100 \mu\text{g}/\text{m}^3$ .

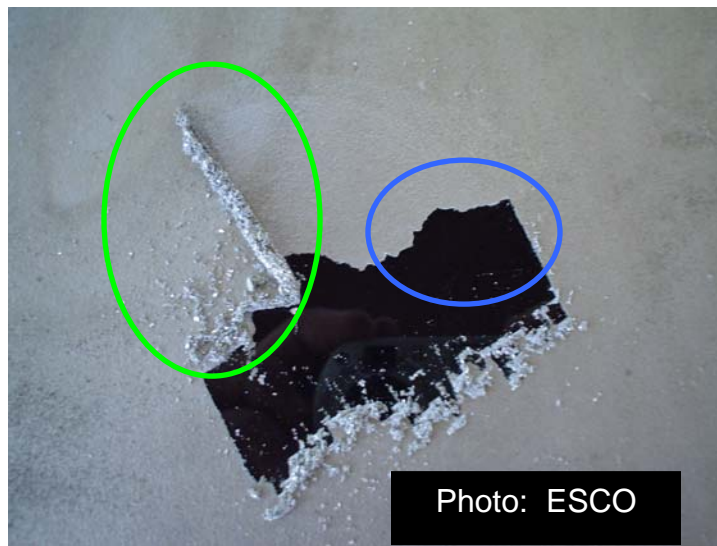
The following photograph shows how the tin amalgam behaves when scraped off the glass. Note how there are crisp edges at the leading edge (blue). Also note when the removed amalgam is pushed together, it binds quite readily (green).

Mercury vapor concentrations of this amalgam were  $>100 \mu\text{g}/\text{m}^3$ .

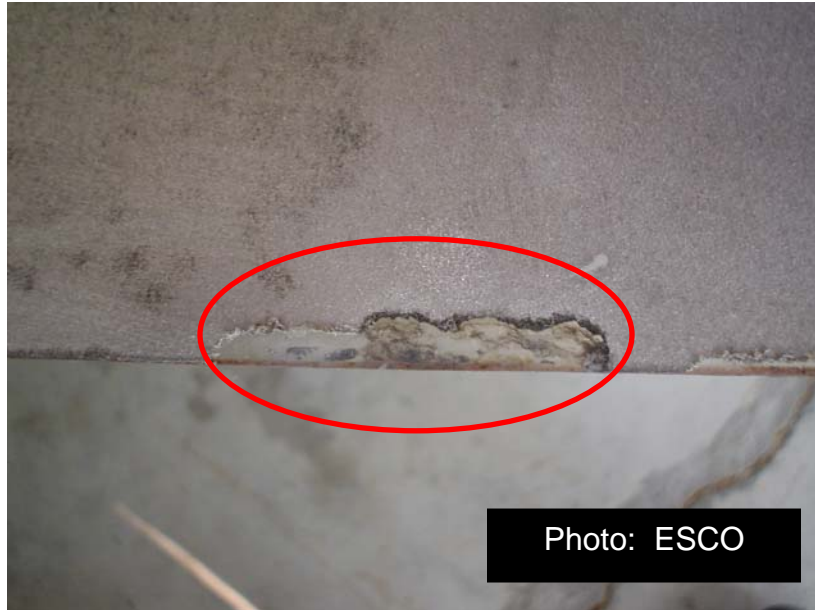
The following photograph shows the detail where braces held the mirror within the frame. It is believed that these areas are where the flakes came from that were earlier observed in the frame and on the floor below the dresser.
